Storage Tank Explosion and Fire in Glenpool, Oklahoma April 7, 2003

Pipeline Accident Report

NTSB/PAR-04/02

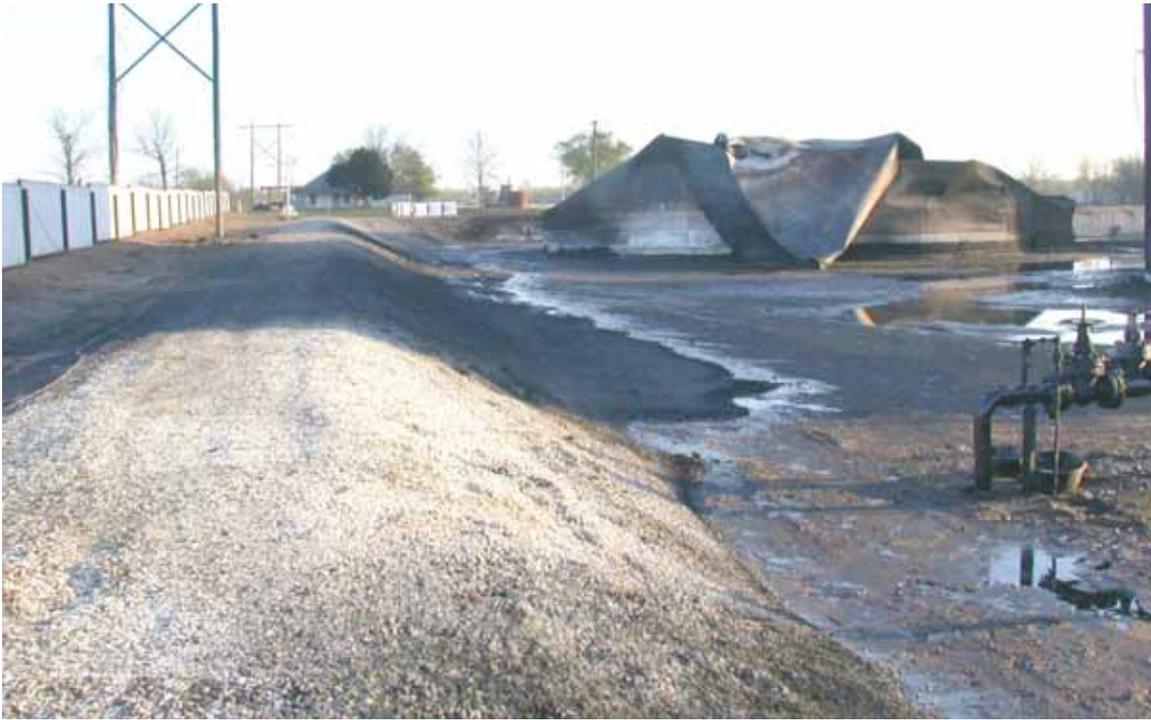
Figure 2. View of wreckage of tank 11 facing south. Note power lines and earthen dike at left and overpressure piping at right.

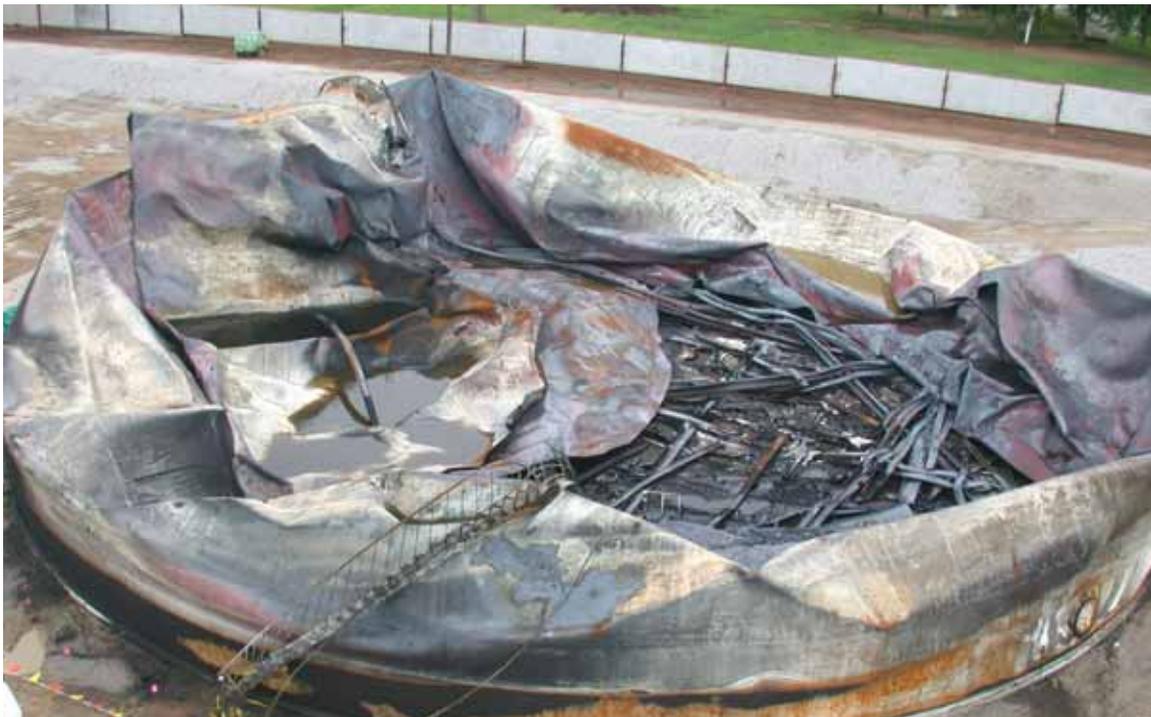
Figure 3. Wreckage of tank 11.

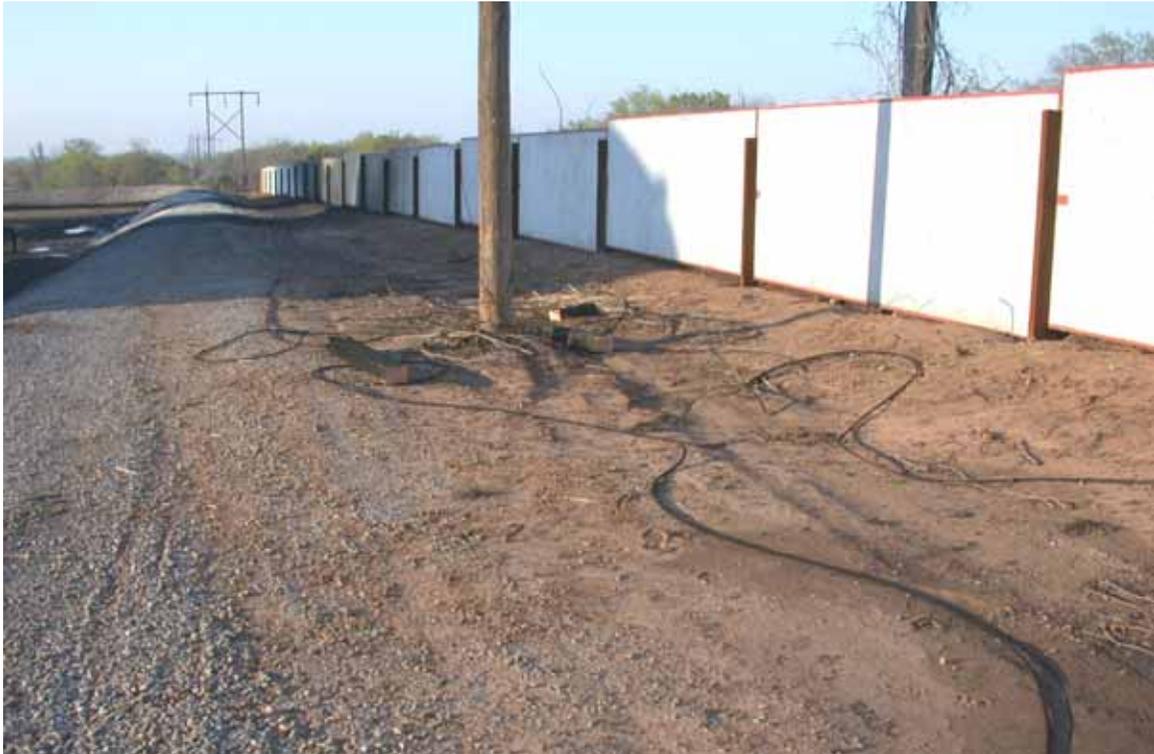
Figure 4. View of downed AEP power lines on east dike wall.

On April 10, 2003, investigators observed the power lines and shield wires on the ground on the east wall of the Glenpool South tank farm dike. The wooden power poles were standing.

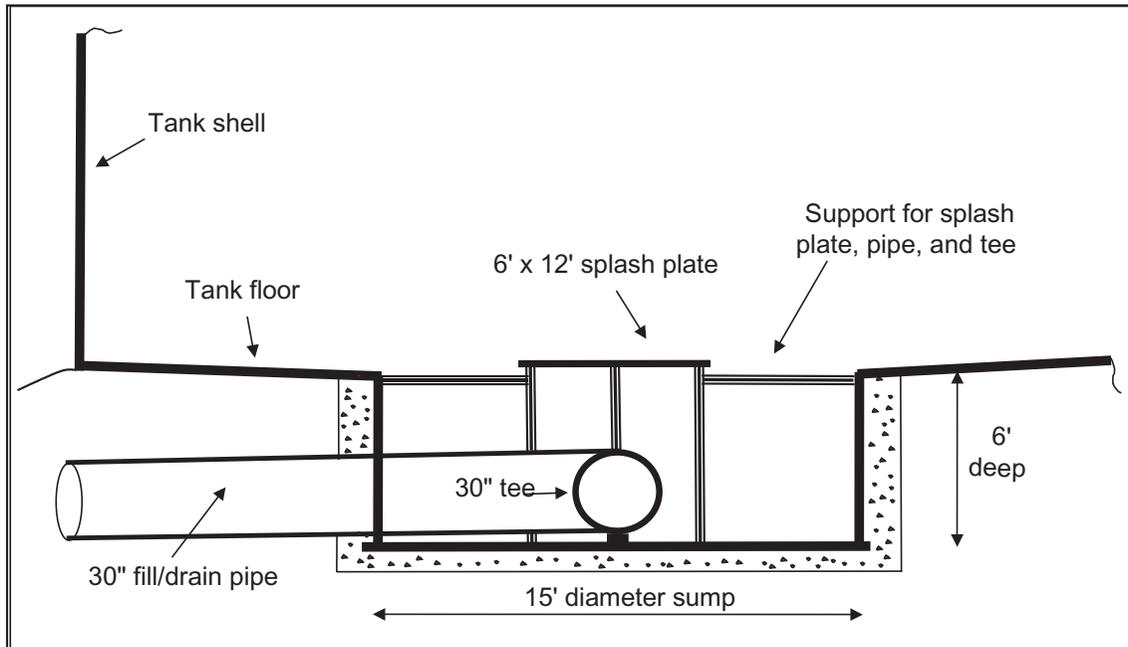
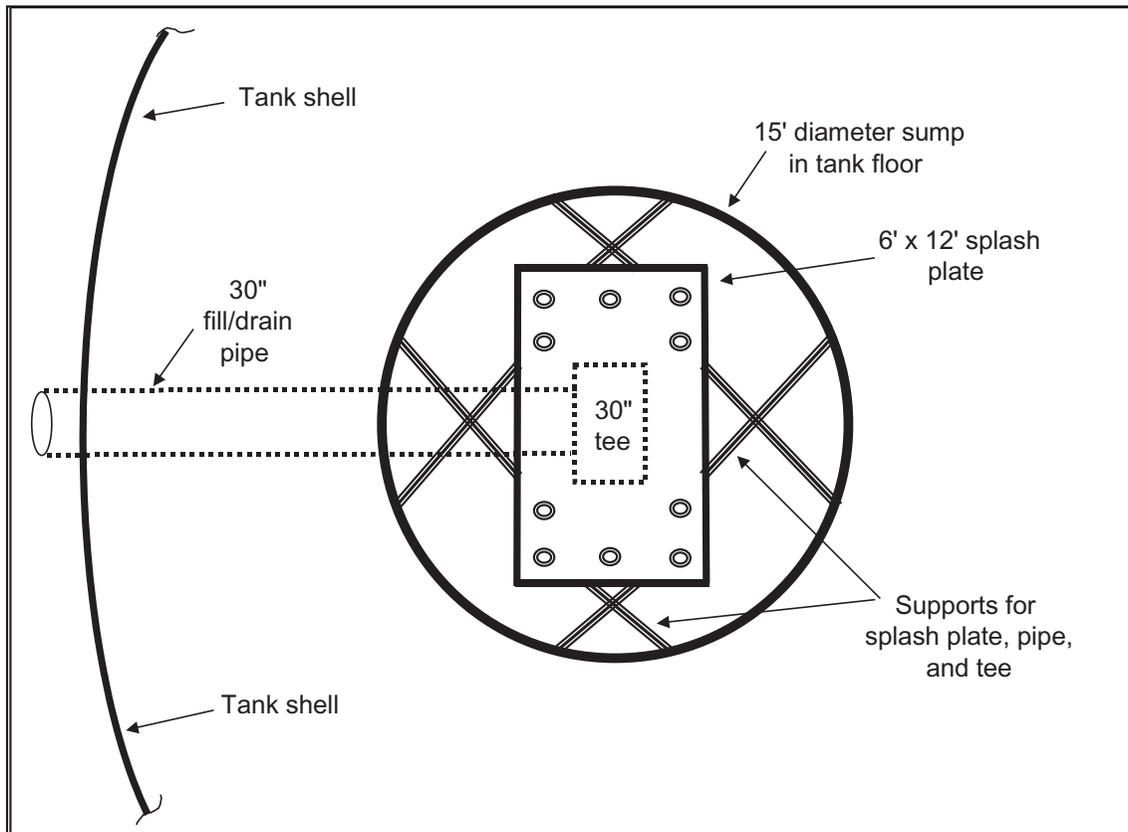
Figure 6. Tank 11 sump and fill/drain piping viewed from the side (top diagram) and from above (bottom diagram).

At the time of the explosion, the tee in the sump at the end of the fill pipe was submerged in the diesel by more than the recommended minimum depth, but the internal roof had not yet floated.

After the accident, tanks 7, 8, 9, and 12 were inspected, repaired as needed, and returned to service. Tanks 7, 8, and 12 were retrofitted by ConocoPhillips with two tees on the existing tee inside the sump with the intent of accommodating a higher flow rate from Explorer. Additionally, the splash plates over the sump openings were enlarged to cover the entire outline of the circular sumps. ConocoPhillips indicated that Tank 11 may be replaced depending on future operational requirements.

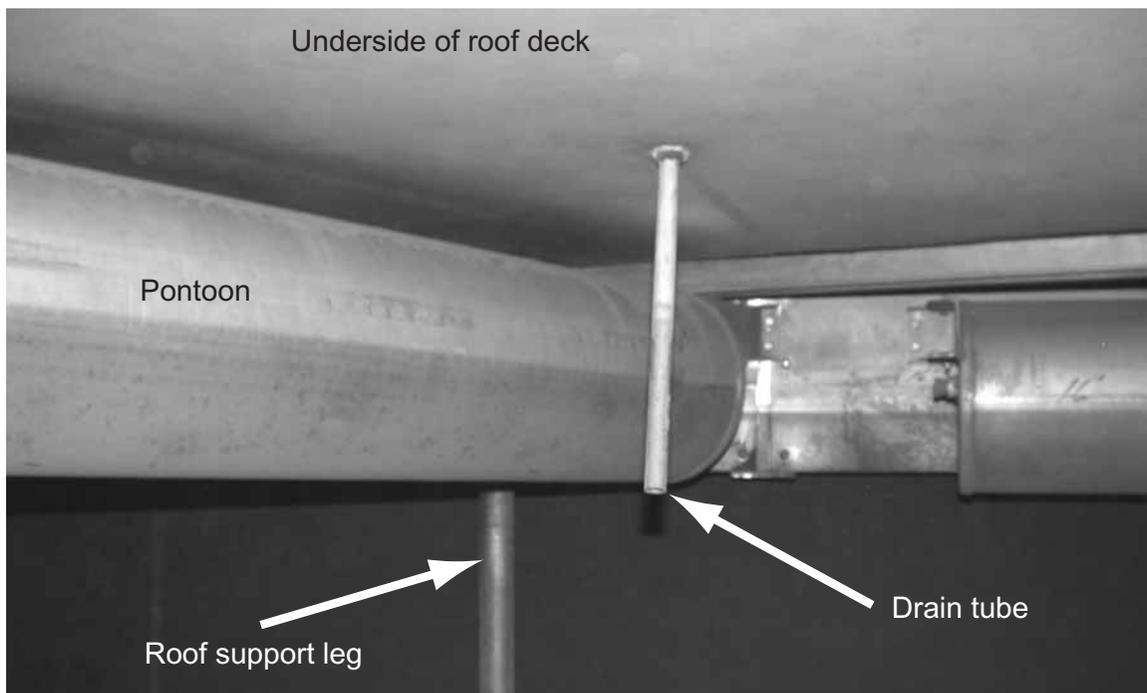
The legs of the floating roof were fitted through aluminum sleeves fastened to the floating roof. The legs could be adjusted to support the roof at different heights above the tank floor when the roof was not floating. Leg length was determined by placing bolts with nuts through predrilled holes in the sleeve and leg above the roof. A bolt and nut could also be placed in the leg below the floating roof to prevent it from descending all the way to the tank floor. Thirty-four legs extended around the interior circumference of the tank, approximately 4 inches inside the tank wall. The interior portion of the roof had about 14 more legs. The strapping table provided to investigators indicated that 7,180 barrels of product would be required to fully float the roof, and that product would first contact the pontoons at a volume of 6,390 barrels. Steel columns that supported the fixed roof extended from the tank floor through the floating roof to the fixed roof. Antirotation cables for the floating roof were installed. The roof had drains approximately 11 inches long. In tank 12, investigators observed that one drain tube was longer than the others and extended below the bottom of the nearby pontoon. (See figure 7.)

Figure 7. Drain tube extending down from floating roof in tank 12.

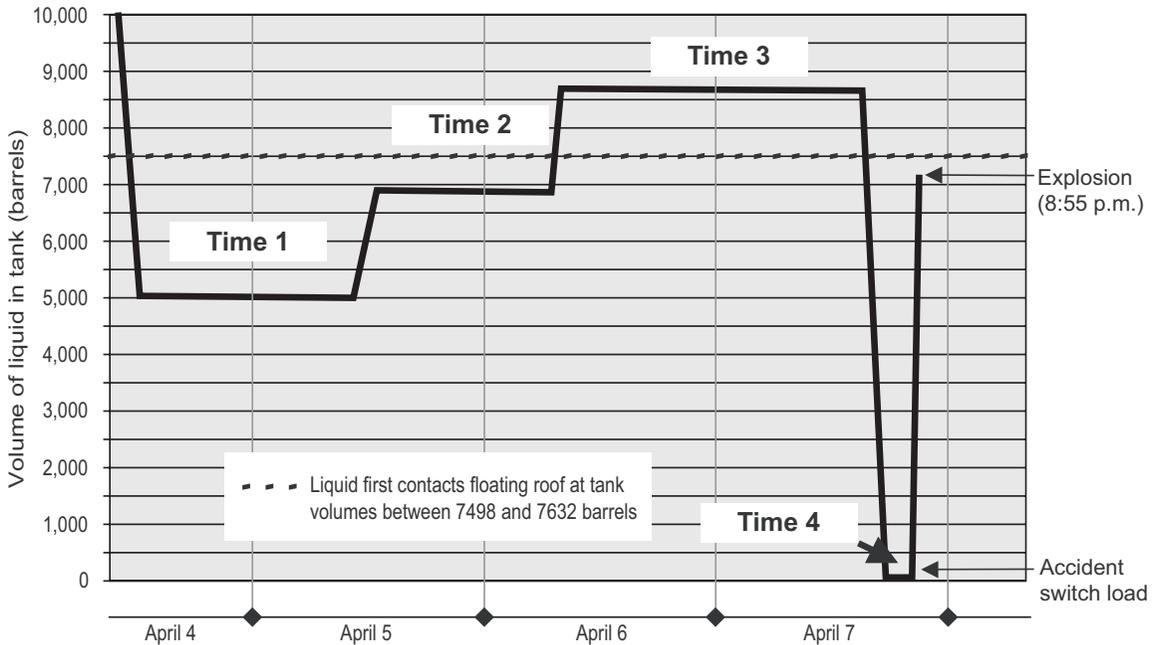
Figure 8. Volume of fuels in tank 11 during the 84 hours before the accident.
